Figure 2-3. Present-day configuration of T-117

PORT OF SEATTLE T-117

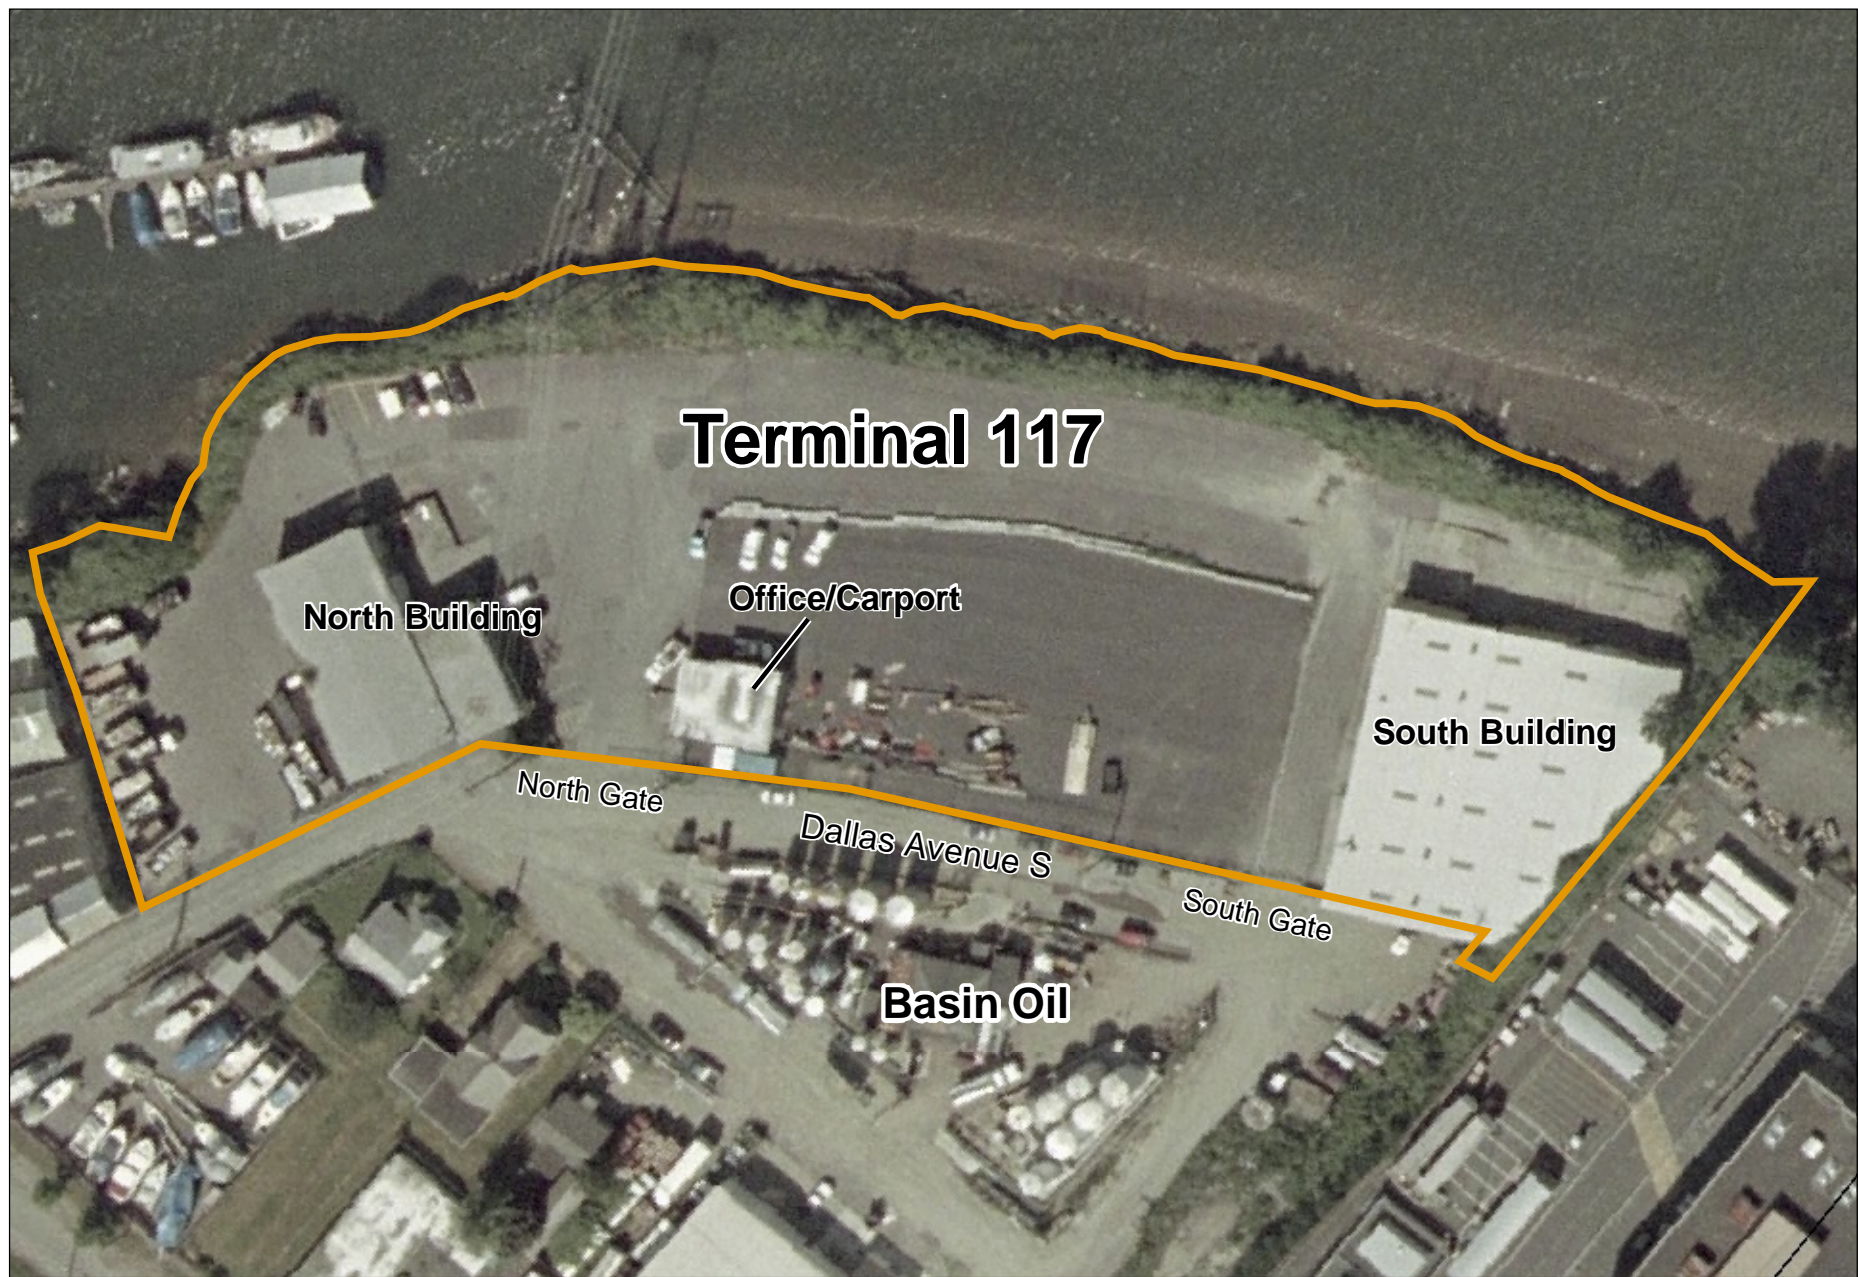
Orthophoto source: King County 2002
